KINGSTON BRASS

INSTALLATION INSTRUCTIONS
For Use With KB's Twin Handles Kitchen Faucet
with or without Sprayer

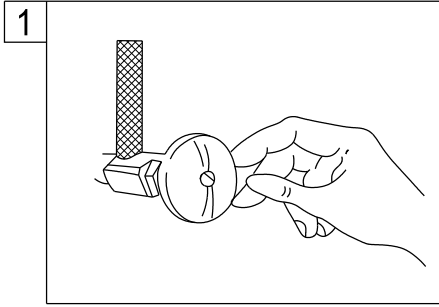
1. Shut off hot and cold water supply under sink. Plug sink drain with cloth to avoid losing small parts. Remove old faucet.

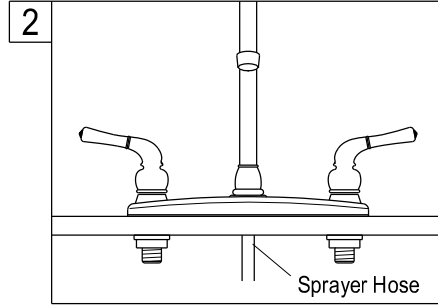
2. Insert the inlet shanks through the sink holes, and press down. Assemble the washers and locknuts on the inlet shanks, and then tighten the nuts by hand.

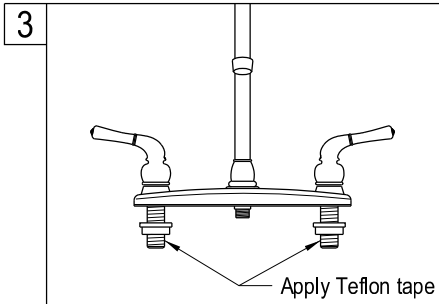
3. Apply Teflon tape to inlet shanks and connect supply lines.

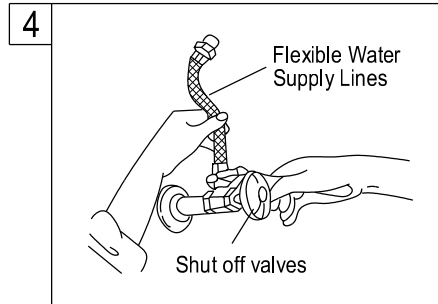
4. Apply Teflon tape to threads on faucet shank and shut off valves, connect water supply line.

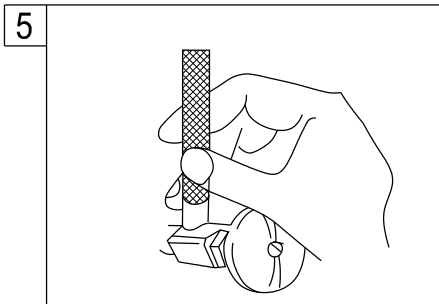
5. Turn on water supply valves and check for leaks, especially all supply line connections.

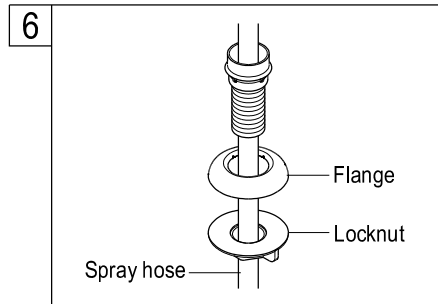
6. For model with spray head and hose, place the spray guide through the fourth hole in the sink, screw the locknut onto the shank and tighten firmly.

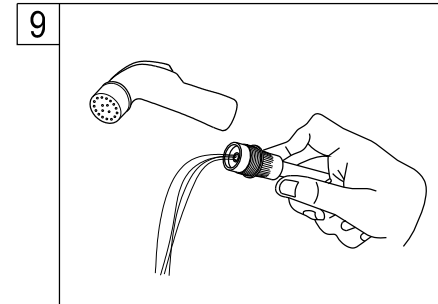
9. Remove spray head by unscrewing the sprayer in a counter clockwise direction, turn on both hot and cold valves and let water run for at least one minute, this will clear any debris left in the line.
