4-163
1 Mode Showerhead
Operation & Maintenance Manual

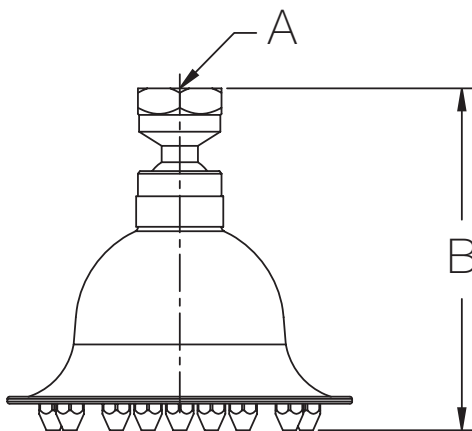
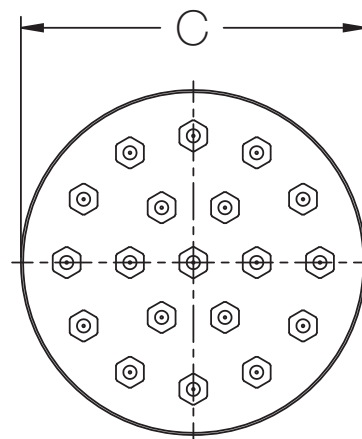
Dimensions

Measurements	
A	1/2-14 NPT
B	3-7/8", 98 mm
C	Ø 3-7/8", 98 mm

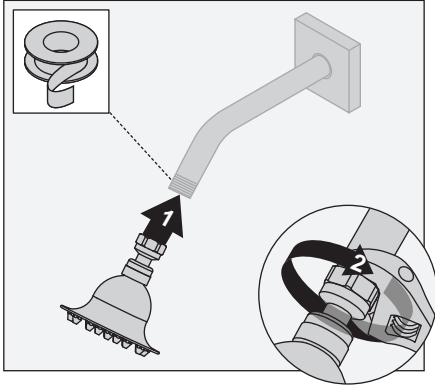
Installation

- 1) Install showerhead to shower arm (not included) turning clockwise to tighten.

Plumber Tape
